Re: Preliminary Geotechnical Report
GC&P Mixed Use Development
City of Wheeling, Wheeling District
Ohio County, West Virginia
LDG Project No. 12540-001

Report of Geotechnical Exploration

GC&P Mixed Use Development
Wheeling District, Ohio County, West Virginia
LDG Project No.: 12540-001

Preliminary Report of Geotechnical Exploration

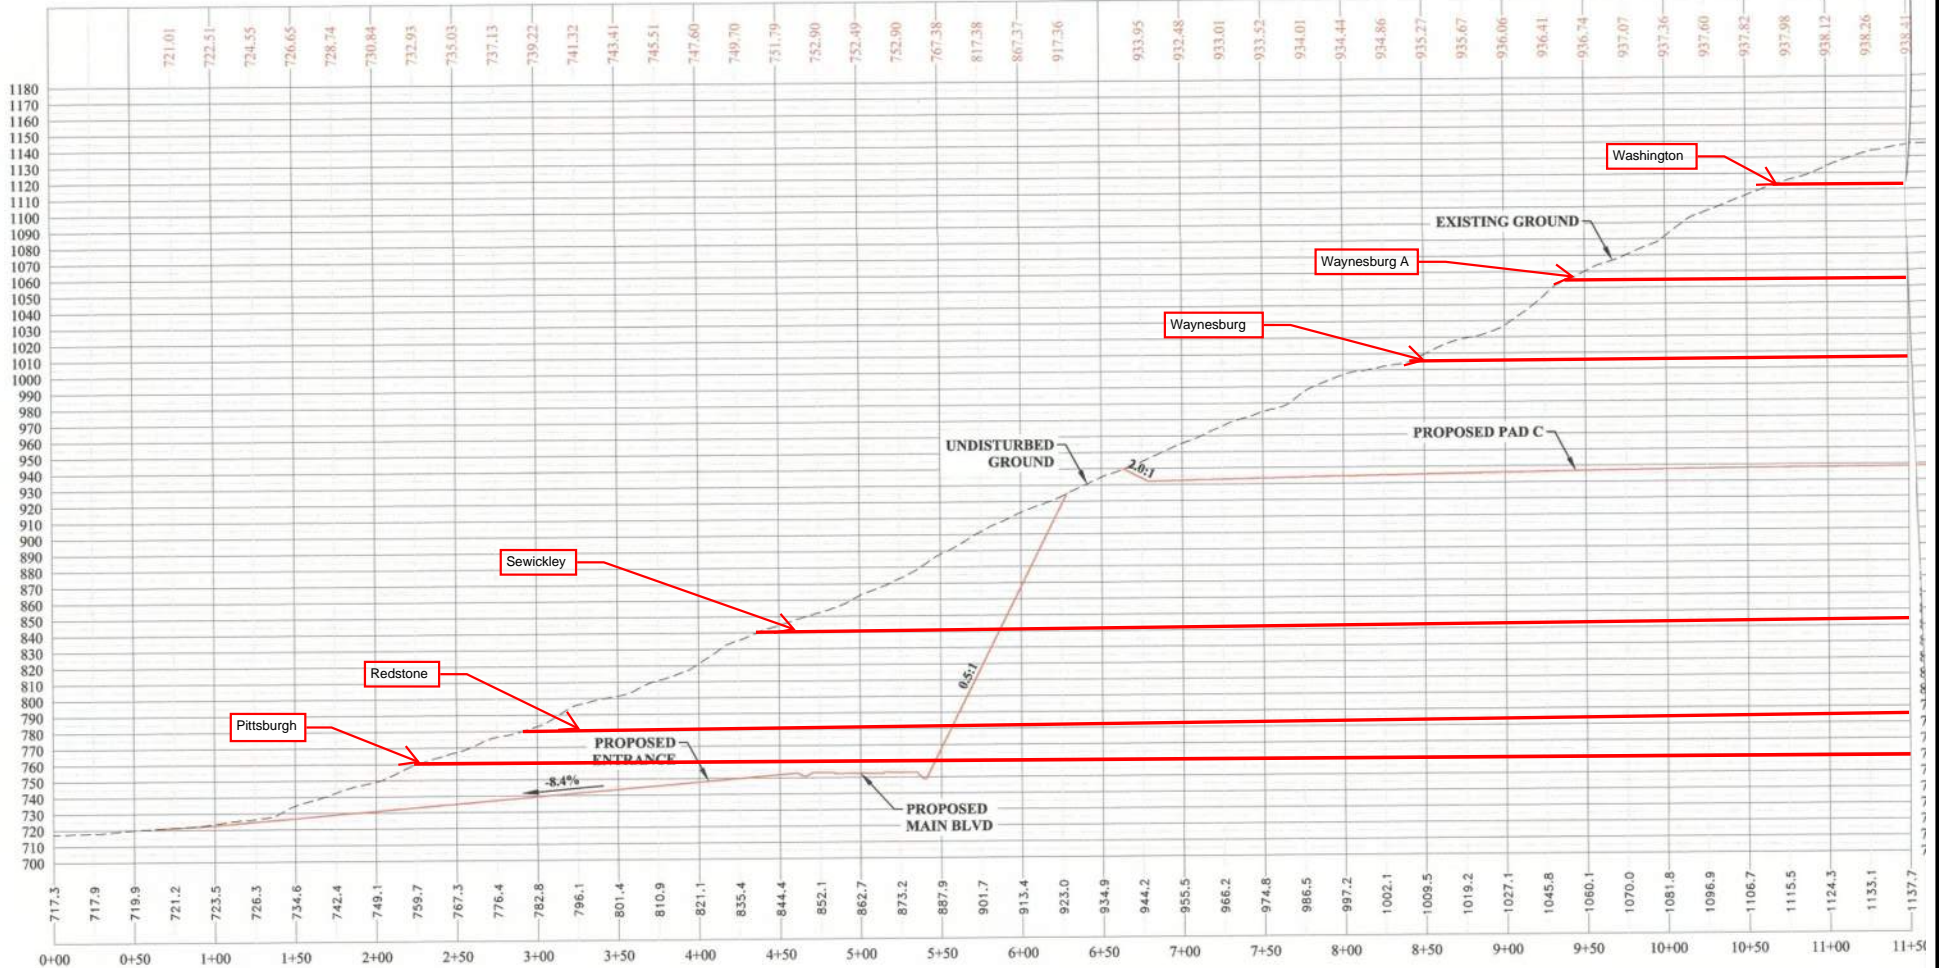
SHEET NO.:
Figure A-5

SECTION C PROFILE

Cross Section C Profile with Coal Elevations
GC & P Development
Wheeling, Ohio County, West Virginia
Coal: WGES MINE MAP ATLAS - Cross Section: The Thrasher Group

Coal beds that may be exposed during the construction of the highwall directly opposite of WV-88 include the Redstone coal located at an elevation of approximately 780 feet, and the Sewickley coal located at an elevation of approximately 845 feet. Each of these coal beds are less than one foot in thickness. It is also anticipated that the Waynesburg coal, located at approximately 1006 feet, the Waynesburg "A" coal, located at approximately 1053 feet, and the Washington coal, located at approximately 1111 feet, will all be encountered as part of the Phase 1 removal of overburden to an elevation of 950 feet for construction of Building Pad C.

For more information on the approximate elevations of the Washington, Waynesburg "A," Waynesburg, Sewickley, Redstone and Pittsburgh coal seams, please refer to Figure A-5. This approximation of elevations is from the WVGES and shows which seams should be expected during the phases of excavation.

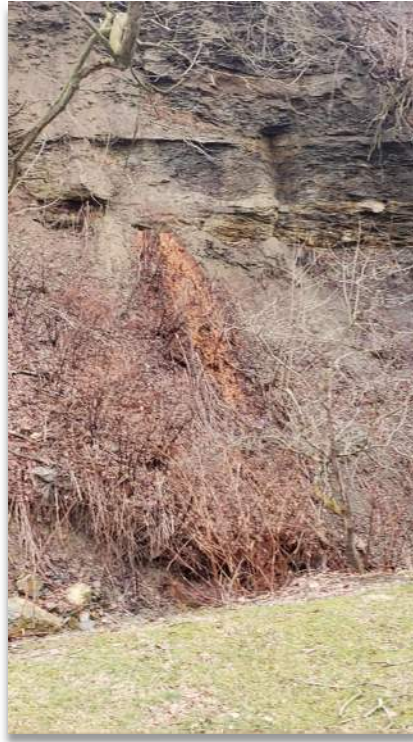
- Rock outcrops were observed above the road level and creek along Bethany Pike. At one location, orange-colored acid mine drainage (AMD) was observed on the rock face. Although not confirmed by survey, it is our understanding that this AMD discharge is from the mined Pittsburgh seam. It is also our understanding that this AMD discharge is off the property.

PHOTO 1: Acid mine drainage along WV-88

Based on the down dip outcrops on the edge of the site, it is not anticipated that a large pool of water exists which would require treatment when the seam is exposed. The condition of the Pittsburgh No. 8 coal seam in the Hutchinson Mine should be determined prior to exposing the seam. Groundwater wells should be installed and sampled to determine the presence of mine water and quality within the Hutchinson Mine and the overlying coal seams. Based on the results of this sampling the potential for AMD treatment can be assessed.

In order to prevent the AMD, sealing techniques should be considered, assessed and implemented. There are several deep mine sealing techniques and the increased hydrostatic pressure from the mine must be considered when a technique is selected.

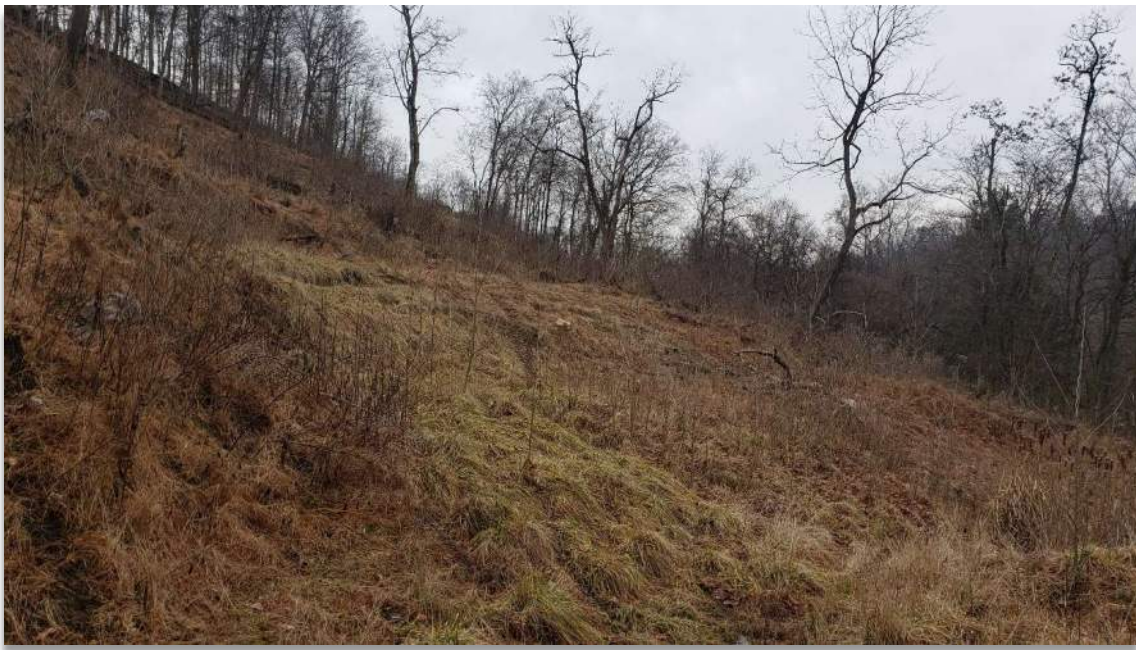
- The slope below the current access road was steep in places and exhibited signs of instability as a result of the soil types. These instabilities are in area that have not been affected by site clearing. As part of the final grading design for the site, slopes will need to be addressed prior to fill placement. A surficial (topsoil) slip was observed at the entrance of the property. We understand that this slip has not been repaired due to the halt work order that was issued for the site. This slip can be readily addressed through normal earthwork operations when construction is allowed to continue.

PHOTO 2: Topsoil slide along property

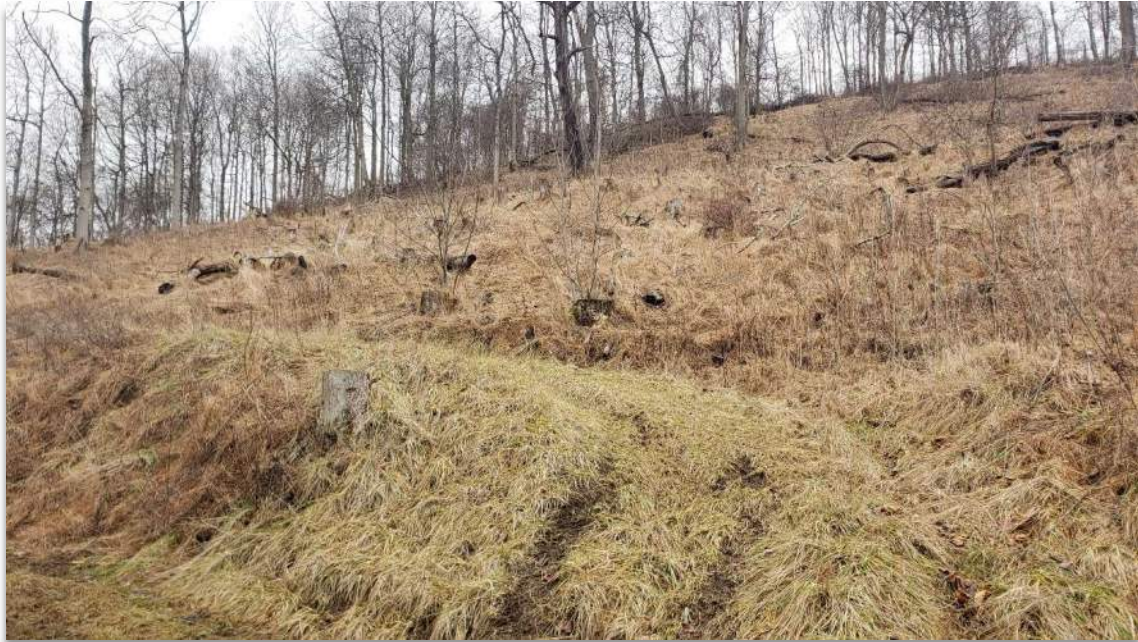
PHOTO 3: Topsoil slide along property

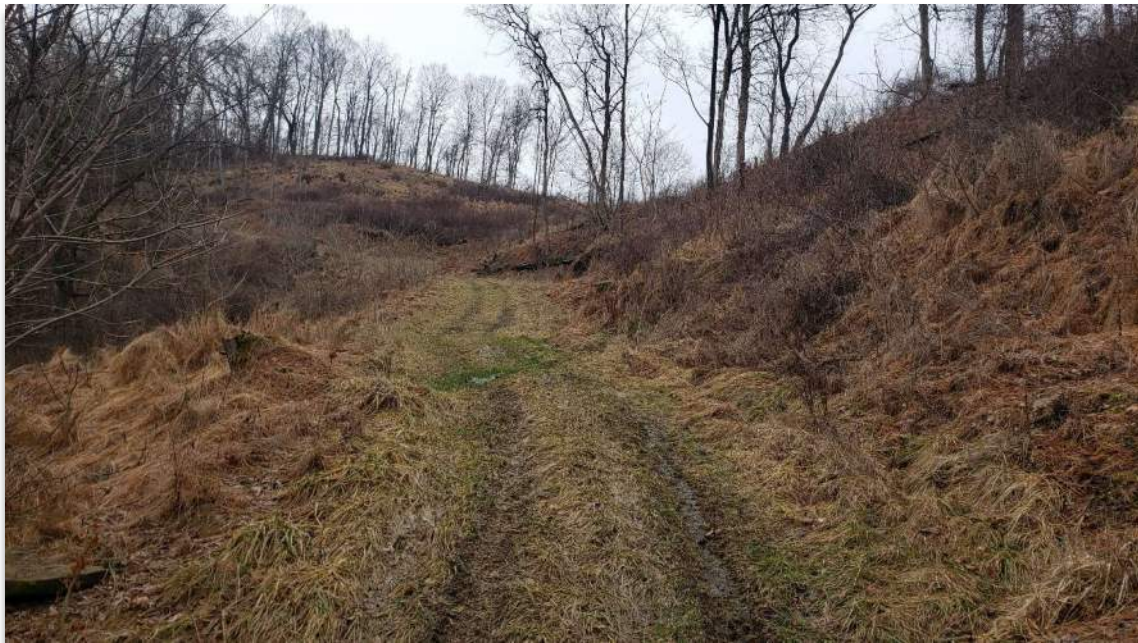
PHOTO 4: View of the cleared hillside from below

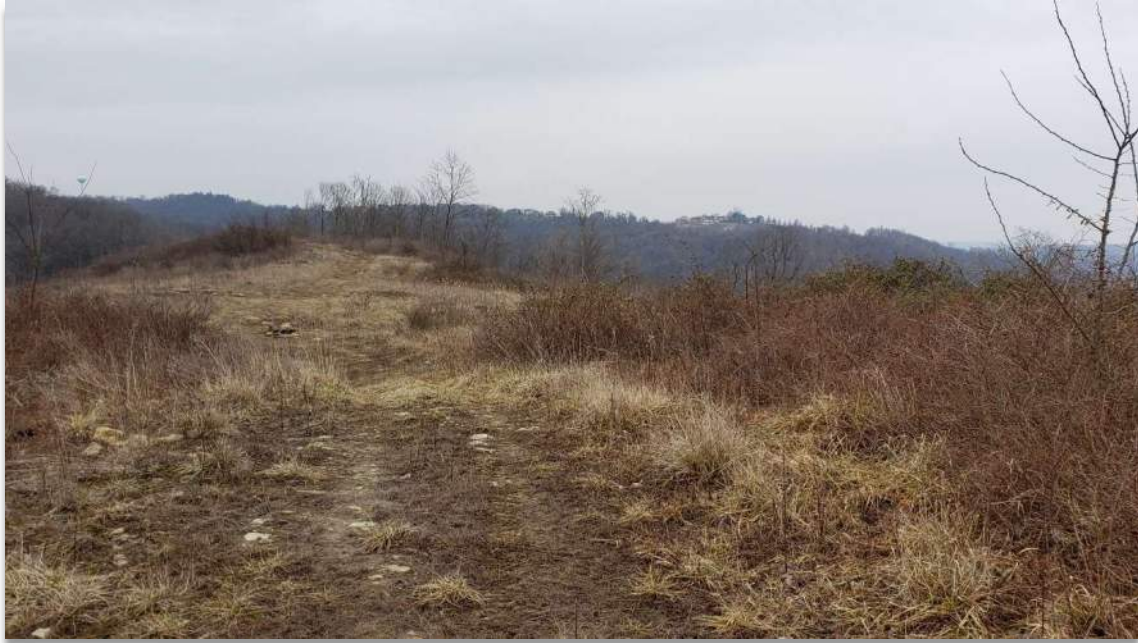
PHOTO 9: Location of B-1 looking west

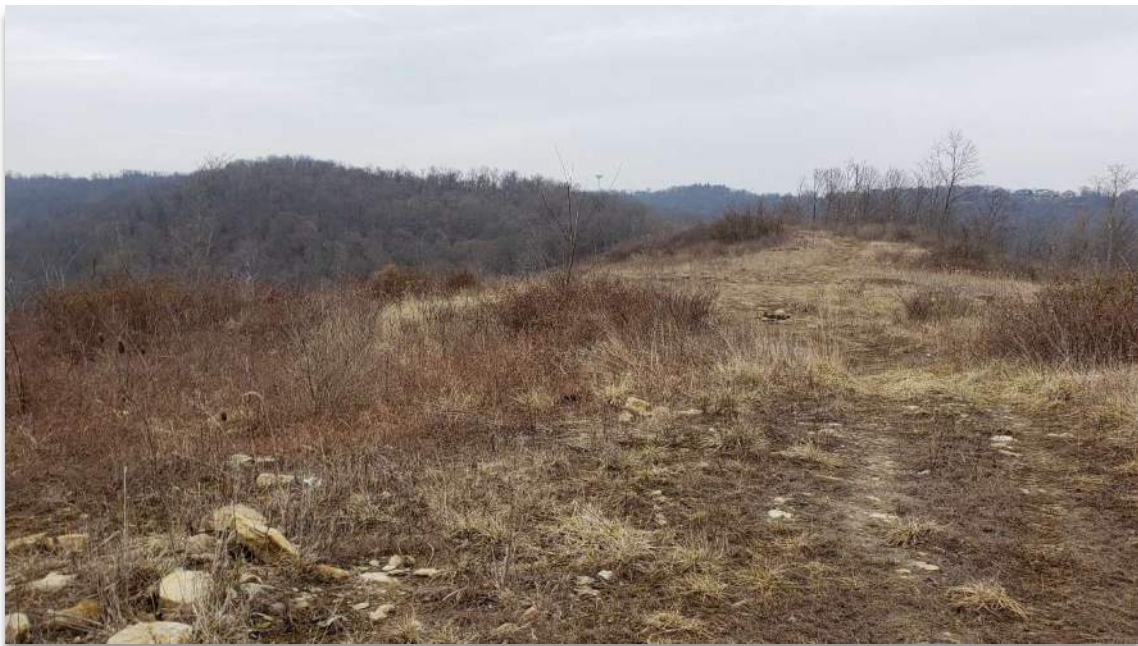
PHOTO 10: Location of B-1 looking west

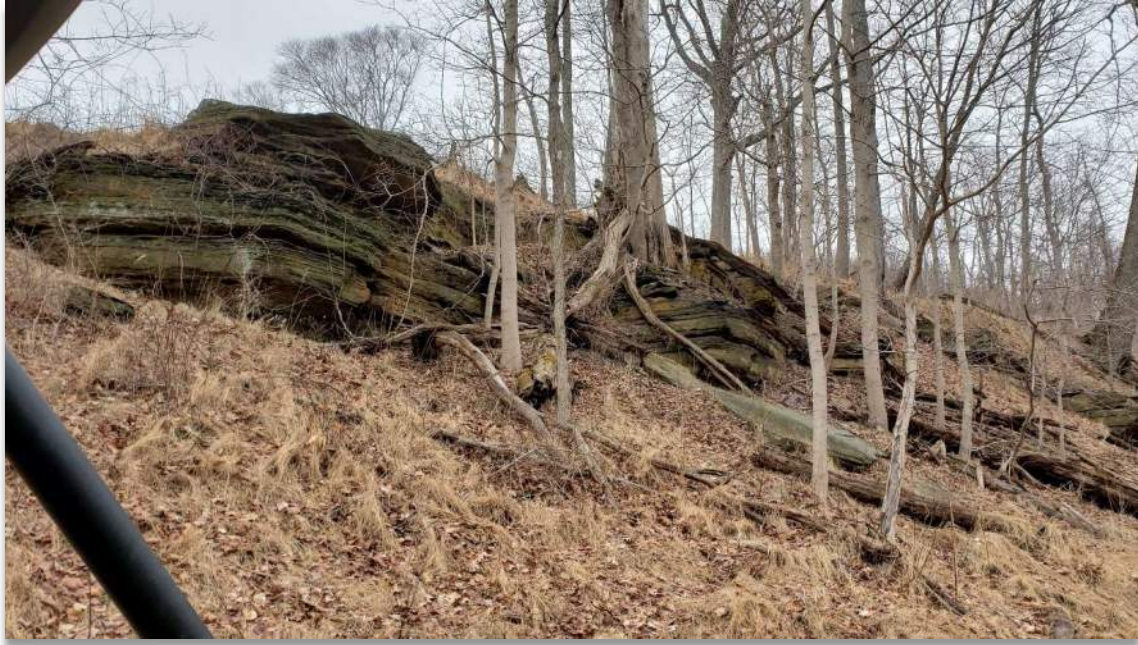
- Various sediment ponds were observed across the site which were reported to be installed as part of the site clearing which was performed.
- The top of the southern slope was observed. Various outcrops were observed along the slope. Near the western edge the outcrops could be observed on the southwest corner of the site. The soil thickness on the southern slope appears to be relatively thin. Although some signs of colluvial soils were visible the slope appears to be in a stable condition. Due to the thin soil overburden we would anticipate that runoff from the slope is fairly intense and fast.

PHOTO 11: Outcrop on the western end of the site, looking east

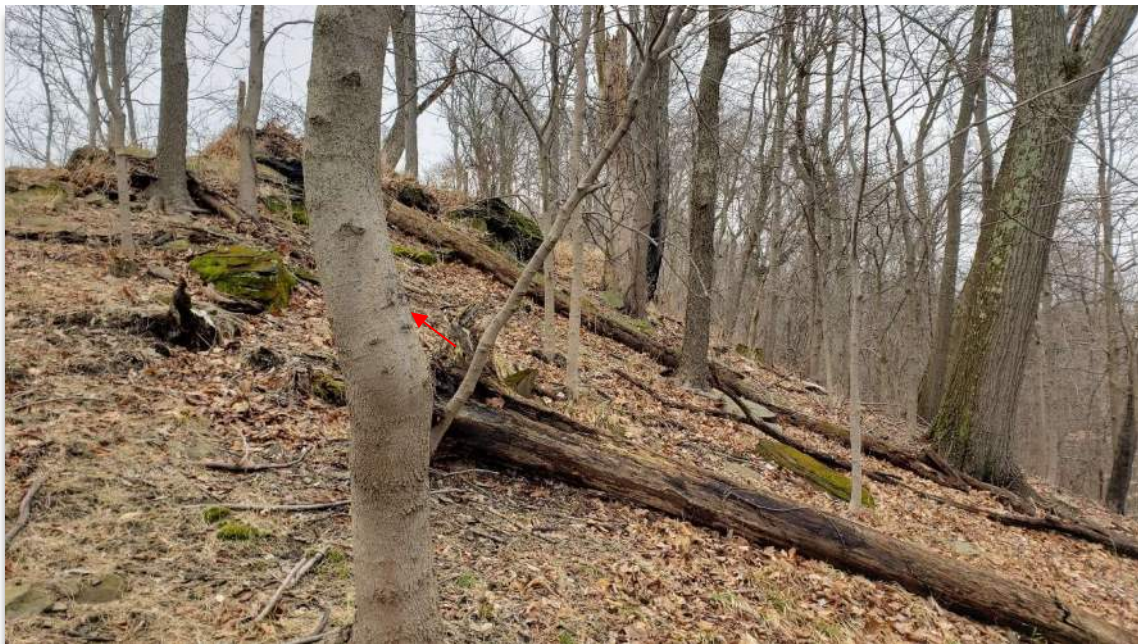
PHOTO 12: Outcrop on the western end of the site, looking east.
Note: Bowed trees indicating slow movement over time
